## GODDARD SPACE FLIGHT CENTER

### Evaluation Report

Microcircuit (10)  
Mfr.: Analog Devices  
P/N: AD8138  
D/C: 0021

Project  
VCL  
System  
Parts testing  
Requester  
K.Sahu (562)  
Initiated Date  
10/01/00  
Investigator  
A.Teverovsky (562)

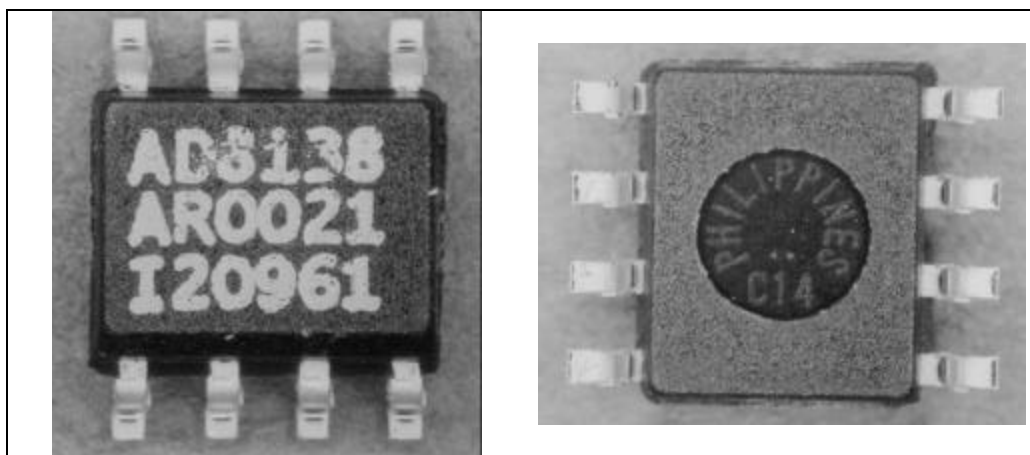
External examination showed that the part had no package warping, cracks, voids, or foreign inclusions in the plastic encapsulant. No gaps were observed between the entry of the leads and the molding compound (MC). Figure 1 gives external views of the part.

Figure 1. Top and bottom views of the part.

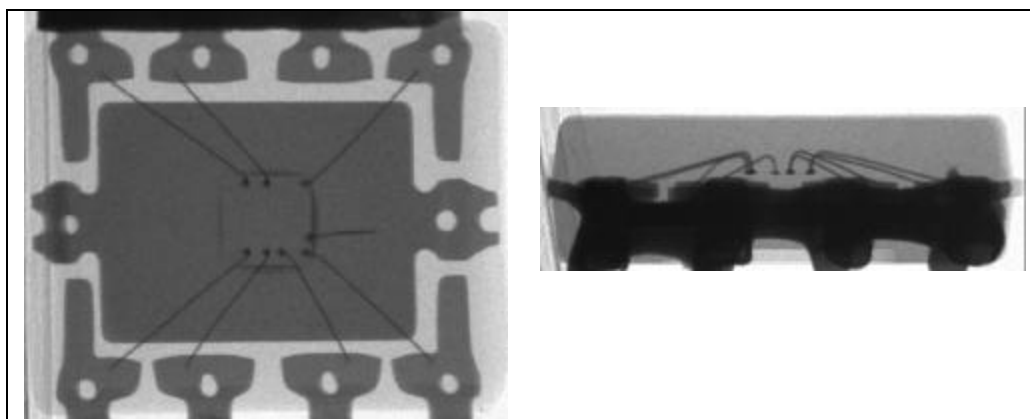
Radiographic examination showed adequate wire bond dressing. The die-paddle and the leads had lead lock holes which enhanced a bond between the molding compound and the lead frame and increased moisture resistance of the part. Typical top and side X-ray views of the part are shown Figure 2.

Figure 2. Typical top and side radiographic views of the part showing adequate lead frame design, wire dressing and layout.

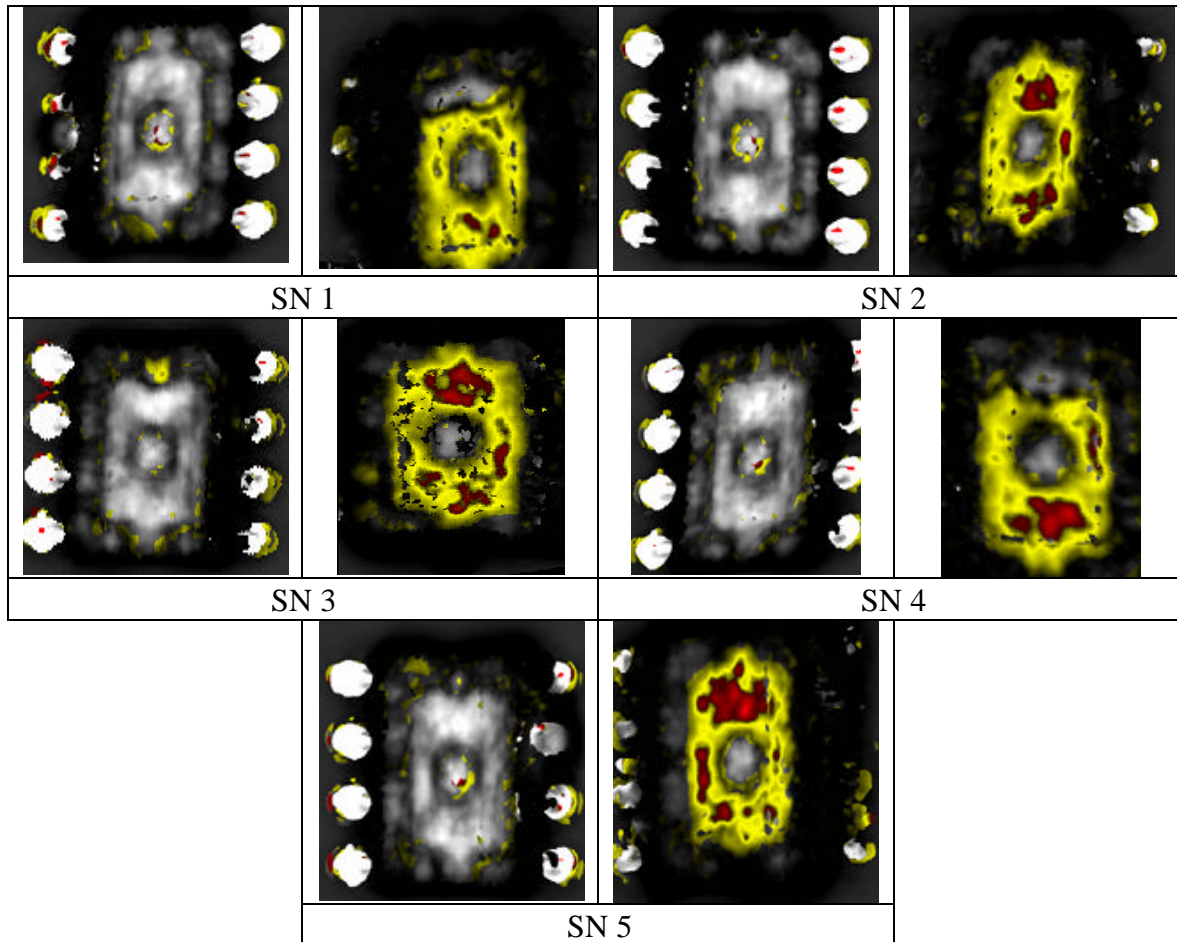
External visual examination after solder pot simulation did not reveal any defects. C-SAM examination showed that delamination at the paddle-molding compound interface has developed in all parts (see Figure 3). No abnormalities at the die-molding compound interface or lead fingertips were noticed.

Figure 3. Analog Devices AD8138 acoustic images before (left) and after (right) solder pot test.  
Top side.

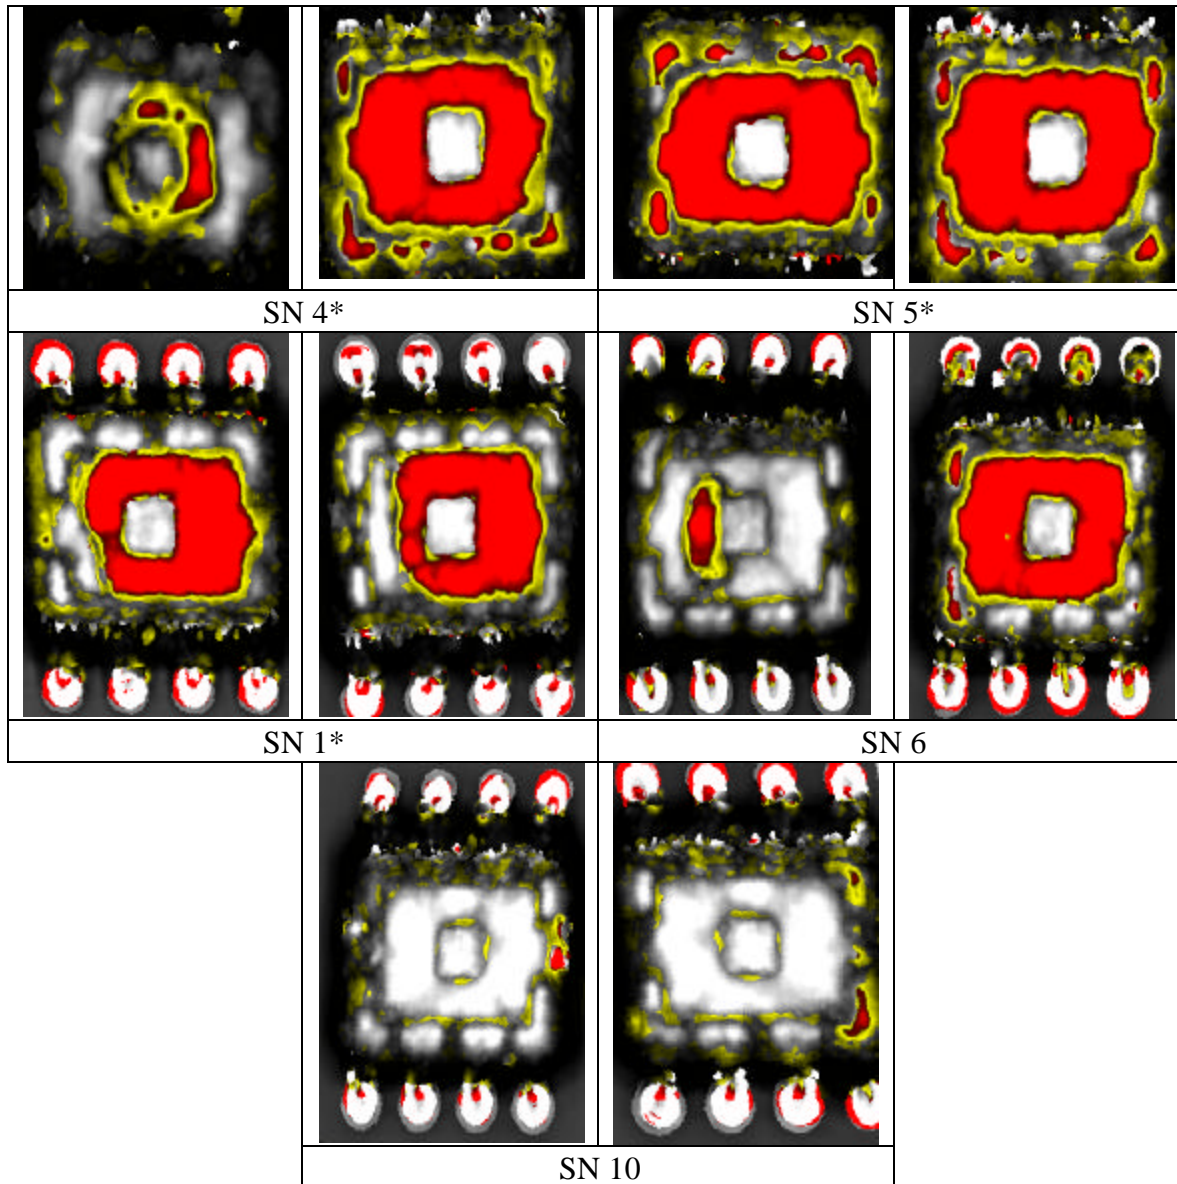
One new part withstood cycling without any changes (SN 10), however, in another part (SN 6), which had initially only small area of delamination at the paddle-MC interface, the area of delamination was significantly increased. Electrical testing of the parts at room temperature did not reveal any anomaly suggesting that the observed delaminations did not affect integrity of the parts.

All parts, which had been stressed by the solder pot test, had completely delaminated paddle-MC interface after temperature cycling. However, none of the parts had delamination at the die-MC interface.

Figure 4. Acoustic images before (left) and after (right) 100 temperature cycles between  $-65^{\circ}\text{C}$  and  $+150^{\circ}\text{C}$ . Top side. Samples 1, 4, and 5 were subjected to the solder pot test before temperature cycling.

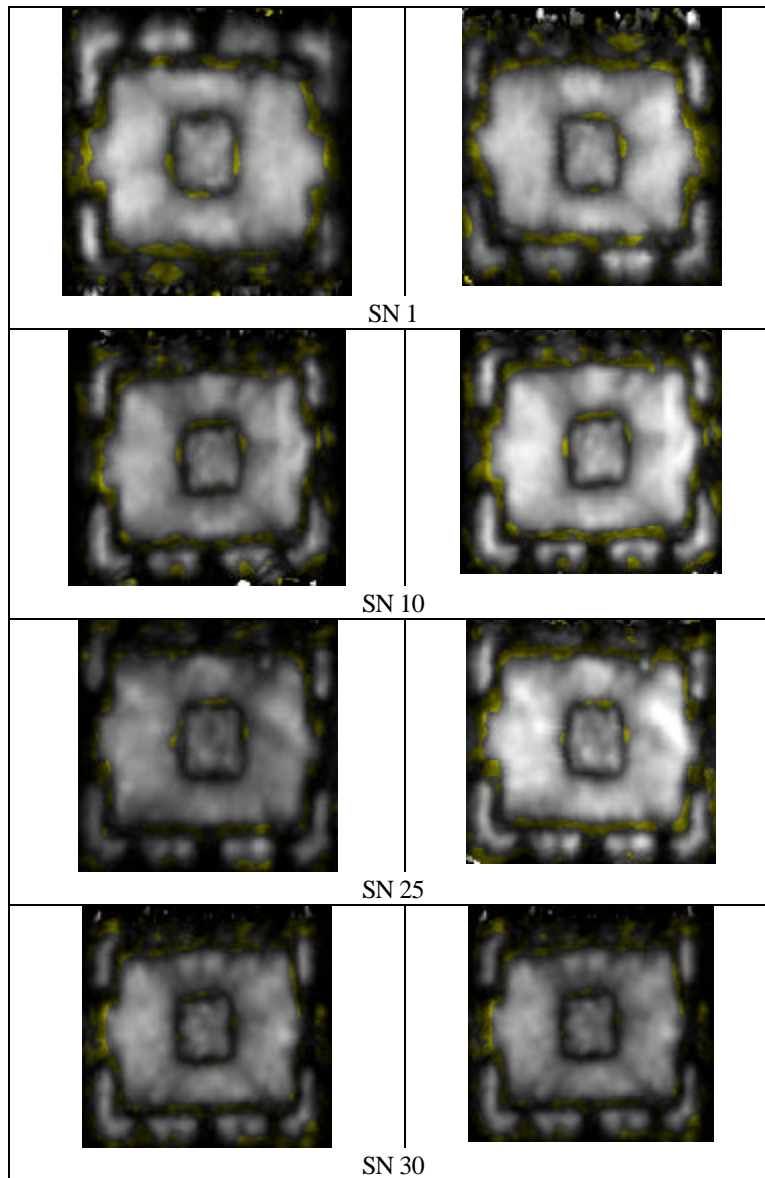
The above results suggest that the part might have problems when subjected to severe thermo-mechanical stresses. To ensure proper quality of the flight parts at normal conditions C-SAM examinations were performed on 30 AD8138 microcircuits before and after 20 temperature cycles  $-20^{\circ}\text{C} + 85^{\circ}\text{C}$ . The original purpose of this test was to pick the best candidates for space applications. The results showed that none of the parts had delaminations or any other defects neither before nor after the temperature cycling. This demonstrates that all parts in the flight lot have adequate thermo-mechanical integrity and robustness under normal conditions. Figure 5 shows typical acoustic images of the flight parts before and after temperature cycling.

Figure 5. Typical acoustic images before (left) and after (right) 20 TC -20 °C to +85 °C. Top views.

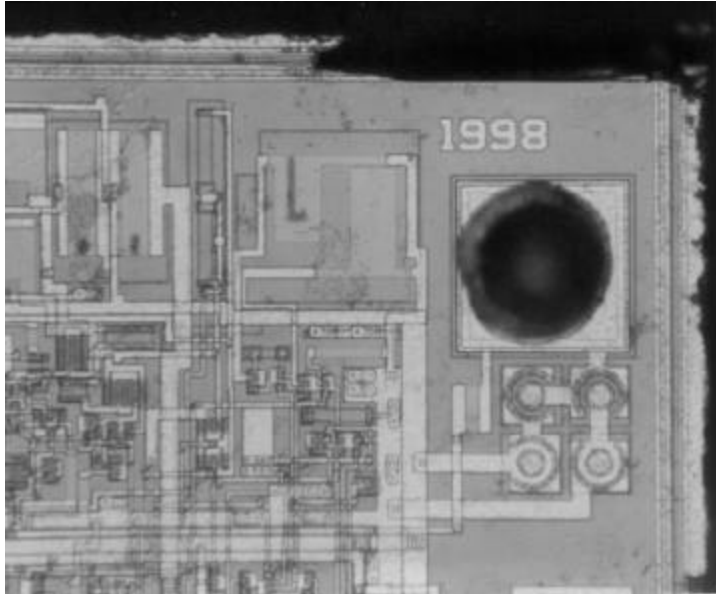
Two samples were decapsulated in red fuming nitric acid and examined under high power optical microscope. No abnormalities in metallization patterning, glassivation integrity or wire bonding were observed. One die had a chip-out (see Figure 6) which did not affect the active area of the die and thus is not rejectable.

Figure 6. Chip-out in this die did not affect the active area of the microcircuit. (200X)

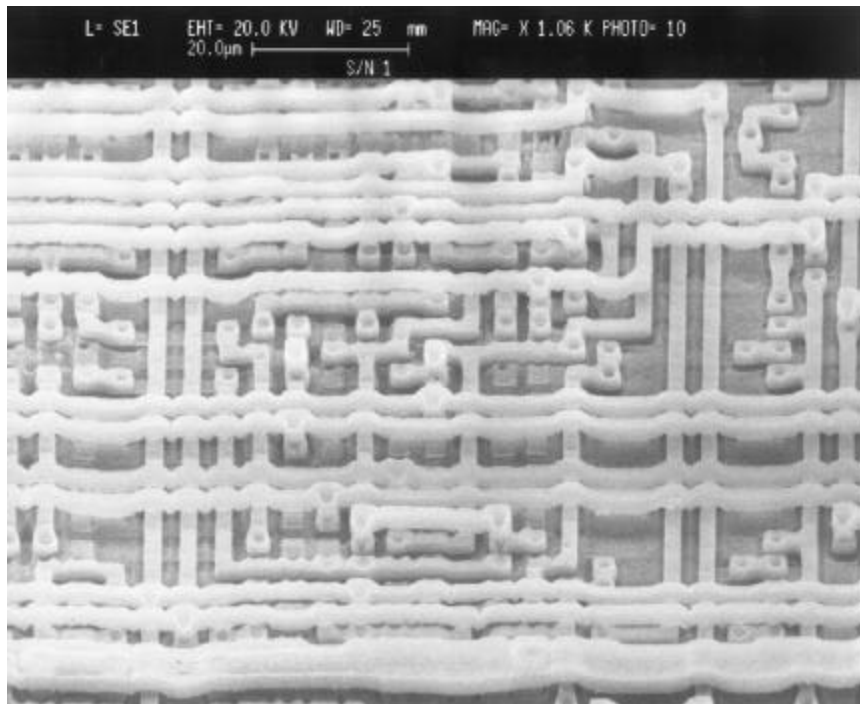
The quality of metallization was inspected in two samples per MIL-STD-883D, Method 2018 (see Figures 7 to 9). The part has two aluminum metallization levels. The first level employs a thin Ti/W barrier layer (see Figure 10). No patterning or step coverage problems were found in either the top or the bottom metallization layers. Some misalignment in the level 1-to-level 2 contact windows (see Figure 9) did not exceed the acceptable level.

Figure 7. Overall SEM view of the die metallization. (1000X)

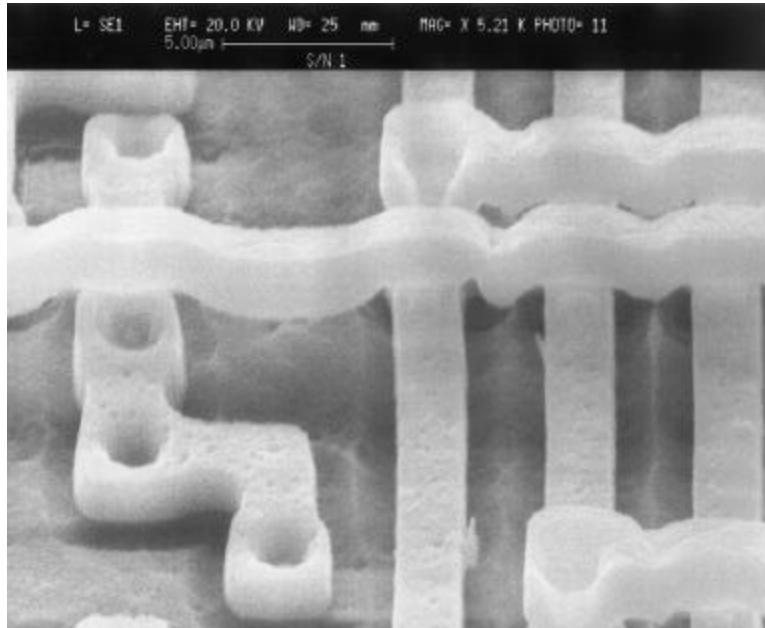
Figure 8. Close-up SEM view of the metallization. (5100X)

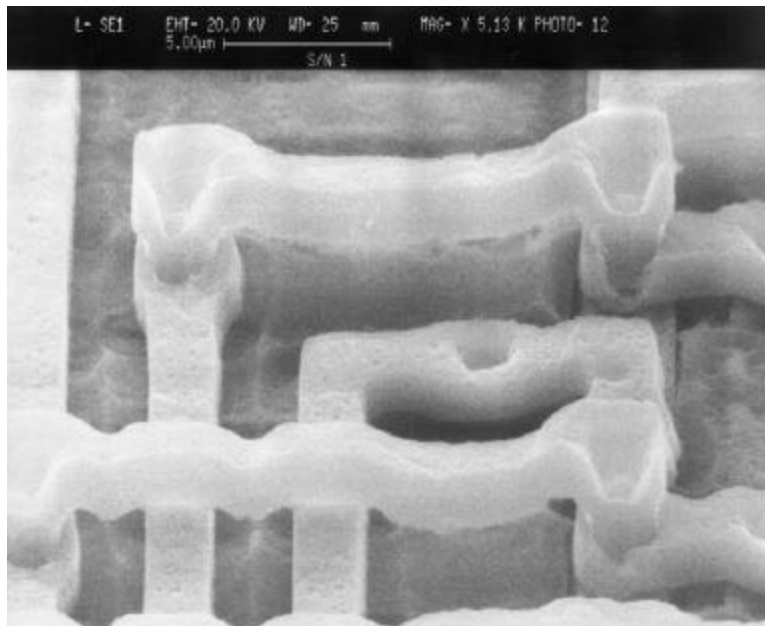
Figure 9. Misalignment in the level 1-to-level 2 contact windows did not exceed the acceptable level.

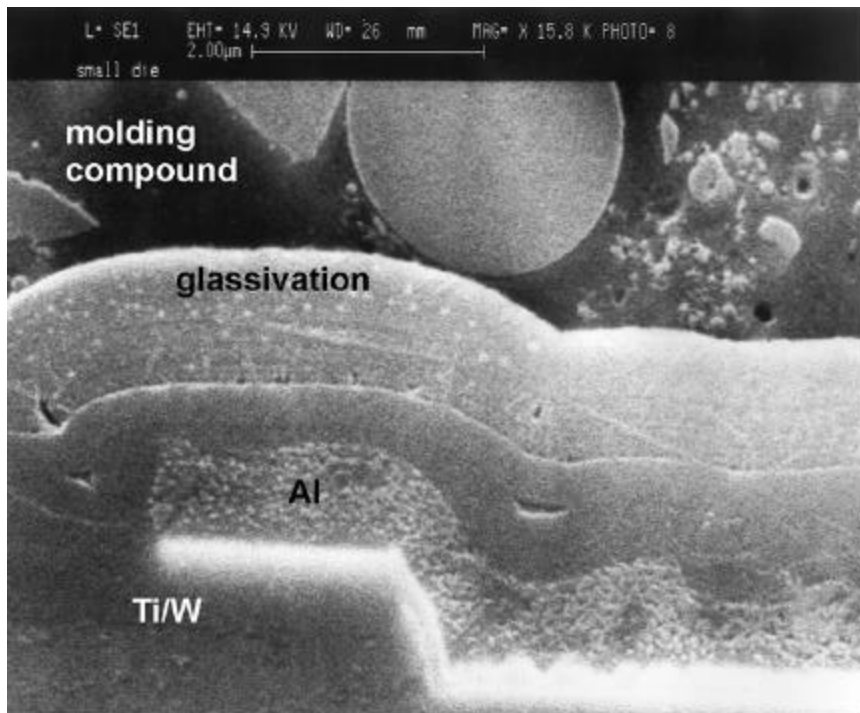
Figure 10. SEM view of the die cross section showing Ti/W barrier layer. Note also an intimate contact between the molding compound and the glassivation layer.

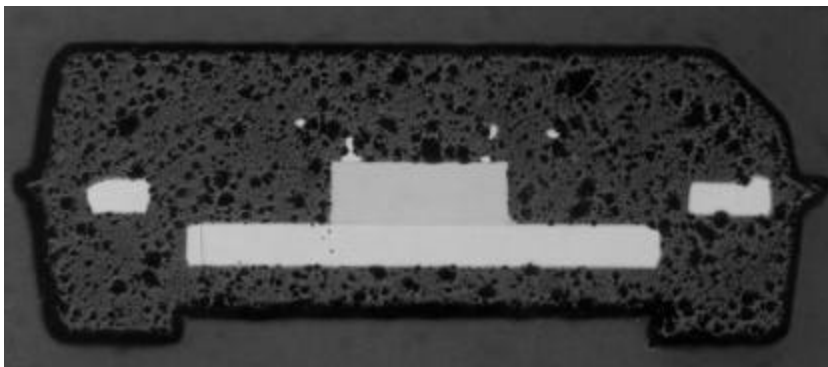
The molding compound had no internal cracks or voids and formed intimate contacts to all internal surfaces (die, wires, and lead frame). No delaminations between the glassivation and the molding compound were observed.

Figure 11. An overall view of the package cross section.

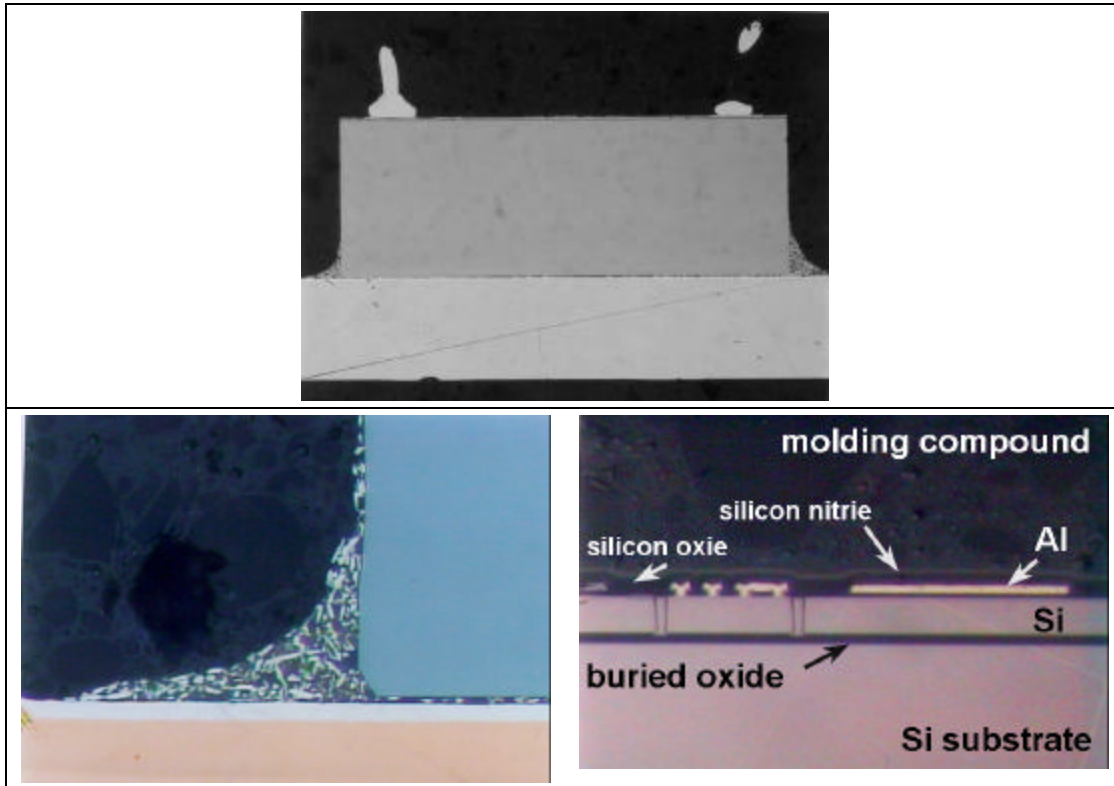
The die was mounted to the lead frame base with a thin layer of silver epoxy. The adhesive and silver filler were uniformly distributed along the die-paddle interface.

Figure 12. Die cross section (a) and close-up of the die attachment (b) and die surface (c).

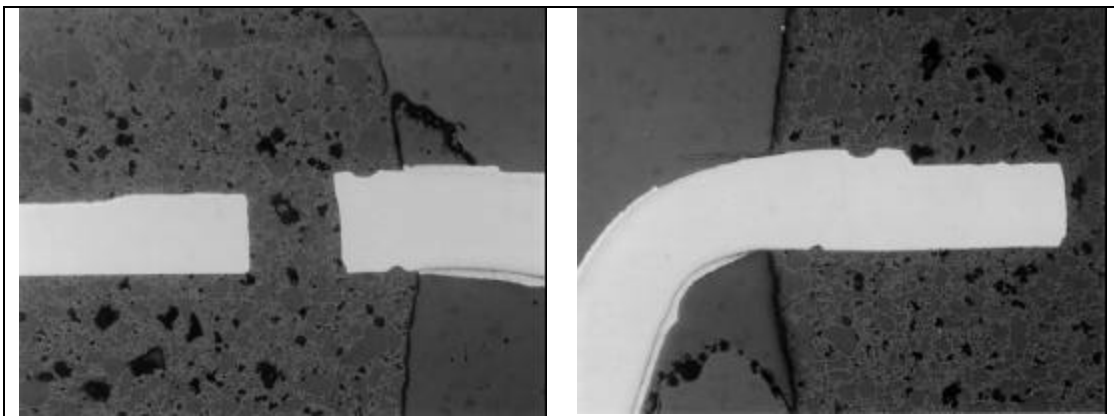
Figure 13. Cross-section of the lead entries showing intimate contact at the lead-MC interface.  
(100X)

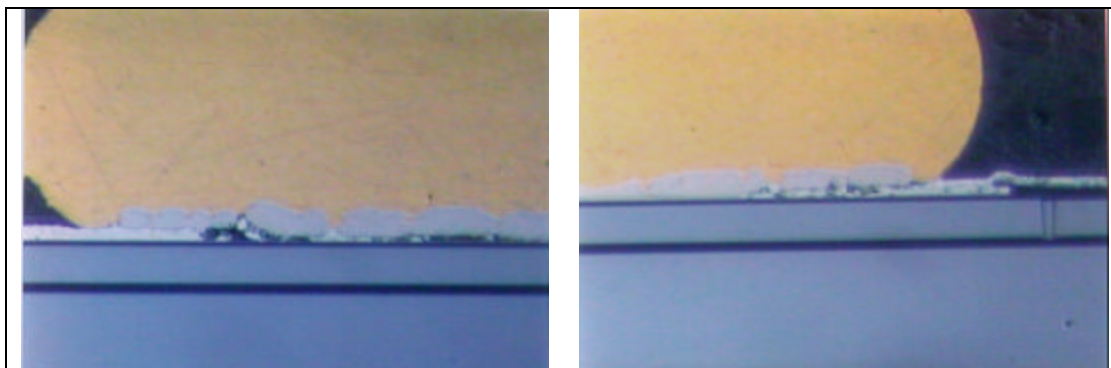
Ball bond cross sectioning showed the formation of an adequate Au/Al intermetallic layer of 2 - 3  $\mu\text{m}$  in thickness (see Figure 14). In many cases a large proportion of the bonded area had the aluminum film completely consumed during intermetallic formation. Although similar condition is

typical for many microcircuits encapsulated in plastics, its effect on the long-term reliability of the part requires additional analysis.

Figure 14. Cross-section of the wire bonds showing adequate Au/Al intermetallic formation at the edges of the bonds and aluminum thinning at the center. (1000X)
